Manhole Inspection Summary

Manhole # S25U__006MH

Insp Date: **3/26/09 1:17 PM**

Location Address: **1500 S. Monroe**

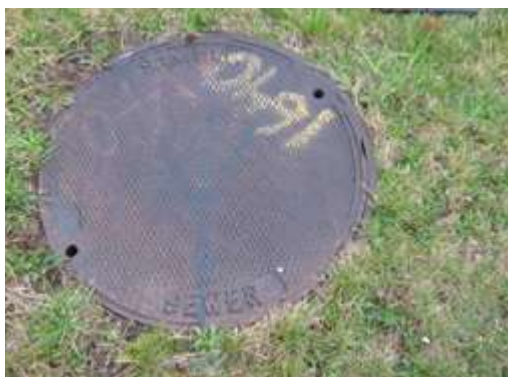
Miscellaneous

mh cover

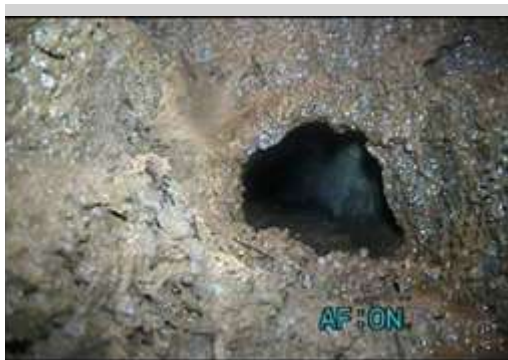
Defect 5

Condition: ☐ Sound ☐ Cracked ☐ Root Intrusion ☐ Deteriorated ☐ Leaks ☒ **Debris**

channel debris

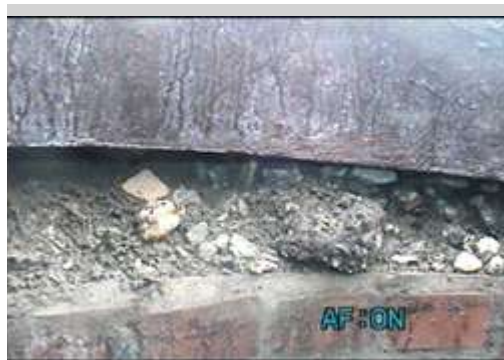
Defect 3

Condition: ☐ Sound ☐ Cracked ☐ Root Intrusion ☐ Loose Brick ☒ **Deteriorated**

Infiltration: ☐ None ☒ **Joint** ☐ Cracks ☐ Mortar ☐ Roots ☐ Wall

deterioration of chimney frame adjustment with infiltration from joint

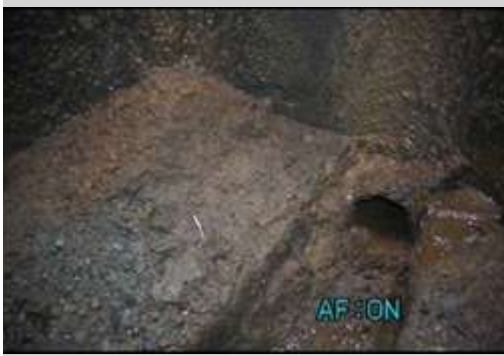
Defect 2

Condition: ☐ Sound ☐ Cracked ☐ Root Intrusion ☐ Deteriorated ☐ Leaks ☒ **Debris**

heavy sediment on bench

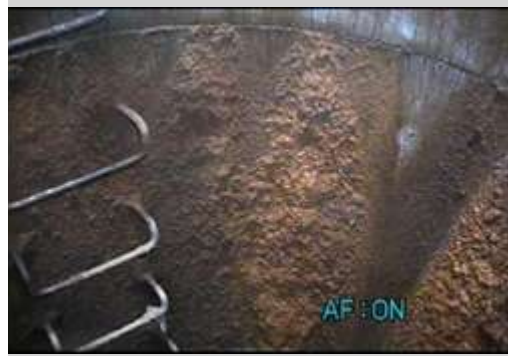
Defect 4

Infiltration: ☐ None ☒ **Joint** ☐ Cracks ☐ Mortar ☐ Roots ☐ Wall

mud deposits on barrel wall show signs of infiltration from barrel joint

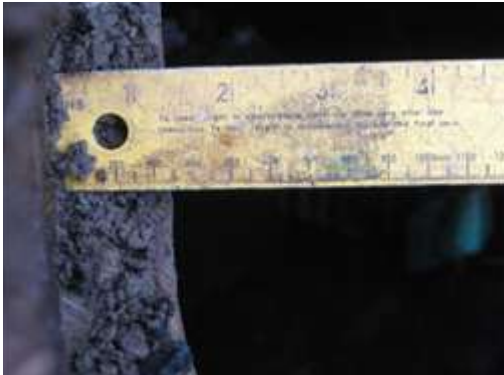
Defect 1

Offset: **1** (in.)

frame offset

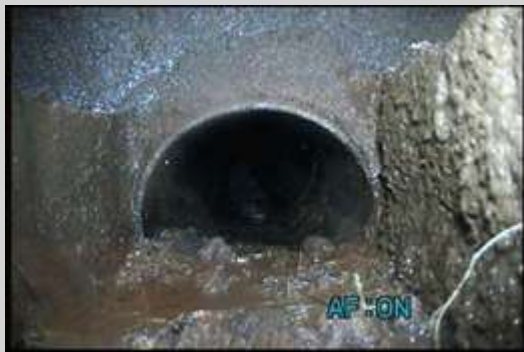
12 O'Clock Outflow

Pipe Height: **8.4** (in.) Rod and Bar (Angled)
Pipe Material: **Clay** ☐ Pipe Lined
Invert Depth: **15.26** (ft.) Flow Characteristics: **Slow**
Deposits: ☐ None ☒ **Mud** ☐ Sludge ☐ Debris ☐ Grease
Silt Depth: **3** (in.) Deposits Extent: **Heavy**
Infiltration: **None** Pipe Seal Cond: **Sound**

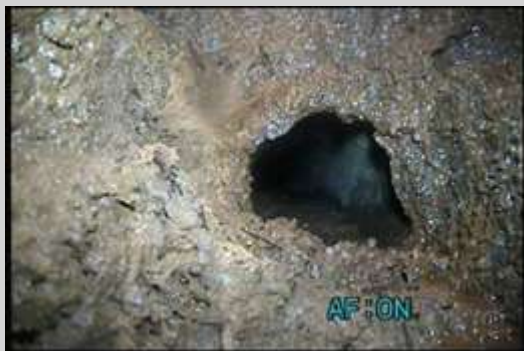
6 O'Clock Inflow

Pipe Height: **6** (in.) Rod and Bar (Angled)
Pipe Material: **Clay** ☐ Pipe Lined
Invert Depth: **15.04** (ft.) Flow Characteristics: **Slow**
Deposits: ☐ None ☒ **Mud** ☐ Sludge ☐ Debris ☐ Grease
Silt Depth: **5** (in.) Deposits Extent: **Heavy**
Infiltration: **None** Pipe Seal Cond: **Unknown**

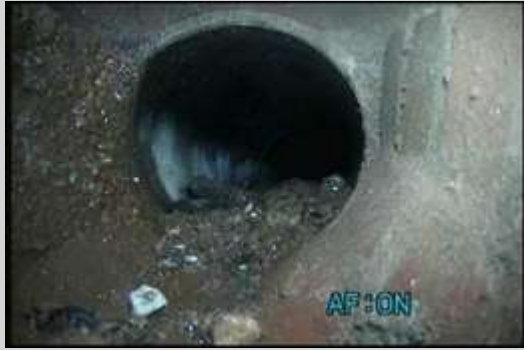
9 O'Clock Inflow

Deposits: ☐ None ☒ **Mud** ☐ Sludge ☐ Debris ☐ Grease

Silt Depth: **3** (in.) Deposits Extent: **Heavy**
